## MEMORANDUM

# July 2<sup>nd</sup>, 2014

**SUBJECT:** Public hearing and consideration of an application for a

Landmark Alteration Certificate to remodel and change the roof form to one side of the contributing accessory building at 2515 7th St. in the Mapleton Hill Historic District, per section 9-11-18 of the Boulder Revised Code 1981 (HIS2014-

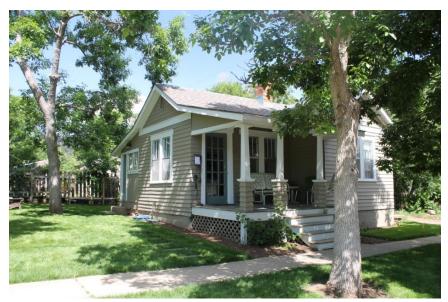
Figure 3. 2515 7th St., house, 2014.

The one-story wood frame house was constructed in 1922 and is an example of vernacular frame design with Bungalow elements, including an intersecting

gable roof with overhanging eaves, a porch with battered wood posts and windows with divided upper sashes. The building remains largely intact from the date of its construction and is considered contributing to the Mapleton Hill Historic District.

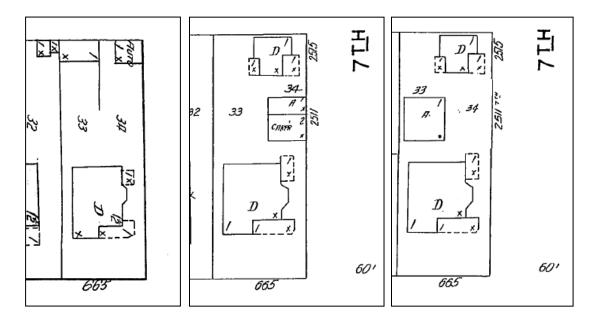
Figure 4. Sanborn Maps L to R: 1922, 1931, 1931-60. The existing accessory building was constructed in 1944.

The accessory building was constructed in 1944 and used as a two-car garage. It straddles the property line between 2515 7th St. and 665 Maxwell Ave. Sanborn Fire Insurance Maps indicate that between 1922 and 1931, a two-story accessory building with a carport extending from the south elevation was constructed on, what was then, 655 Maxwell Avenue. A 1929 tax assessor photograph of 665 Maxwell Avenue (figure 4a) shows a two story building facing onto 7th Street. In 1944, a building permit was issued to the owner of 665 Maxwell Ave. for the construction of a two-car garage. The property was subdivided shortly after, with the east-west property line between 655 Maxwell Ave. and 2515 7th Street running down the middle of the building, presumably giving each address a garage back. Materiality including the novelty drop siding, panel doors and four-light wood casement windows indicate that all or part of an earlier building may have used in the construction of the garage.

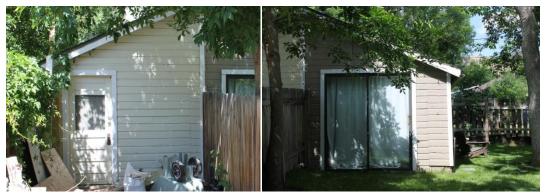
Figure 5. Accessory building, east elevation (south 665 Maxwell Avenue side and north, 2515 7th Street side 2014

The accessory building features a gable roof with overhanging eaves and wooden novelty drop siding, corner boards and trim that appear to be from the original construction. Garage doors on the east elevation have both been modified. The south side (665 Maxwell Ave.) was converted to a pedestrian door and the opening on the north side (2515 7th St.) was modified in the recent past to fit a sliding glass patio door.

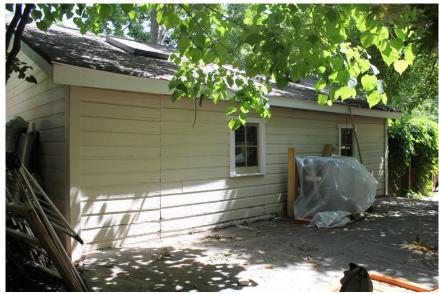
Figure 7. Accessory building, south-west corner facing onto 655 Maxwell Ave., 2014

The north elevation (2515 Maxwell Ave. side) of the accessory building features a three-panel, single light wood pedestrian door at the east end, and two windows.

Both windows have been replaced with non-historic double hung aluminum windows. A bubble skylight is located on the north slope of the roof.

Fewer changes have taken place on the south (655 Maxwell Ave.) side of the building. The east facing garage bay appears to have been in filled with novelty drop siding and a pedestrian door early on. The south face of the building retains two four light wood casement windows and the west end of this elevation appears to have been added. The entire building rests on a concrete foundation.

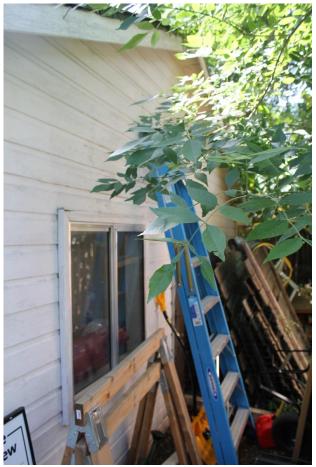
Figure 8. Accessory building, west elevation, 2515 7th St., 2014

The west elevation of the building has a single opening with an aluminum sliding glass window.

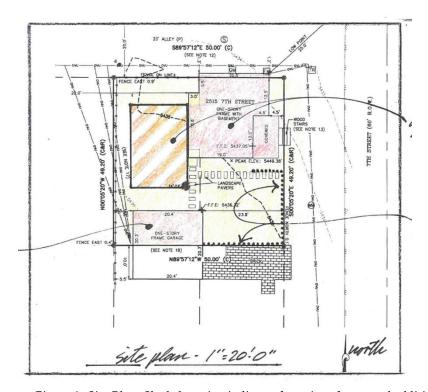
Figure 9. Site Plan. Shaded portion indicates footprint of approved addition.

A site plan shows the footprint of an addition to the main house at 2515 7th St. that was approved by the Landmarks Design Review Committee on May 7, 2014. The proposed alterations will not change the existing footprint of the accessory building. A fence is shown along the south property line (bisecting the accessory building), continuing around the portion of the east property line and returning west approximately 10 ft. along proposed pavers.

The application also calls for the construction of a fence extending from the midpoint of the garage along the south and east property lines, and returning

north approximately 10' (*see Figure 9*). The fence is shown to be 6' in height, with an alternating pattern of 4" and 2" horizontal boards separated by 1" spacing.

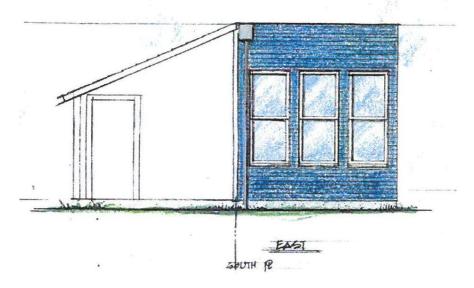
Figure 11. Proposed East Elevation (façade)

The east elevation of the accessory building sits approximately 24' west of the sidewalk along 7th St. Drawings show the north side of the gable to be raised to a create a flat roofed cubic mass measuring 11'6" in height and changing the essential form of the simple gabled garage. The existing sliding glass door is shown to be replaced by three large double-hung windows. The original siding is proposed to be removed and replaced with a narrower lap siding to match the profile and color of the approved addition to the house.

Staff finds that the proposed alterations to the property, including the alteration of the roof form, replacement of siding and reconfiguration of window and door openings does not preserve, enhance or restore the exterior features of the historic property within the Mapleton Hill Historic District, will change the essential mass, scale and form of the building and that such changes will damage or destroy the character of the existing accessory building. The proposed alteration is inconsistent with the treatment of contributing buildings in the *General Design Guidelines* and the *Mapleton Hill Historic District Guidelines* (see Design Guidelines Analysis section).

Staff finds that the proposed change of roof form and, alteration of fenestration and removal of the original siding to be incompatible with the character of the historic district.

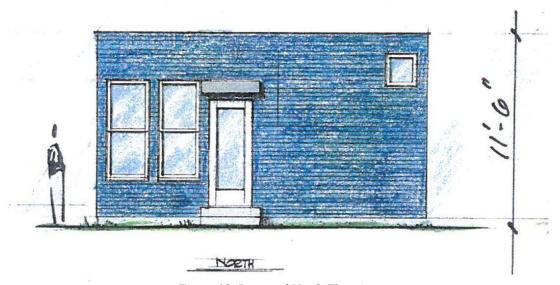
Figure 13. Proposed North Elevation

The openings on the north elevation are shown to be reconfigured so the door is near the center of the elevation, with two double-hung windows at the east end of the elevation. A small casement window is shown in the upper corner of the west side. A concrete stoop is located at the full-light pedestrian door. An overhang is shown over the door on the north elevation but is not depicted on the east or west elevation.

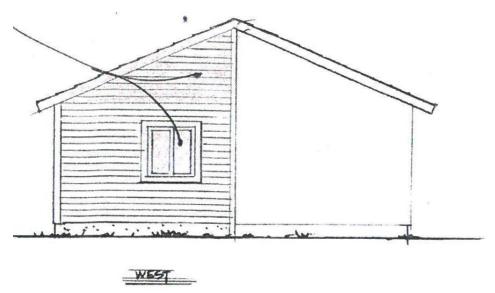
Figure 14. Existing West Elevation

The window opening on the west elevation is to be enclosed and a small casement window located at the north corner of the west elevation. A simple gutter is shown near the center of the west elevation.
